# TOPOGRAPHIC MAP OF THE ACTIVE PART OF THE SLUMGULLION LANDSLIDE ON JULY 31, 2000

Hinsdale County, Colorado

By James A. Messerich and Jeffrey A. Coe

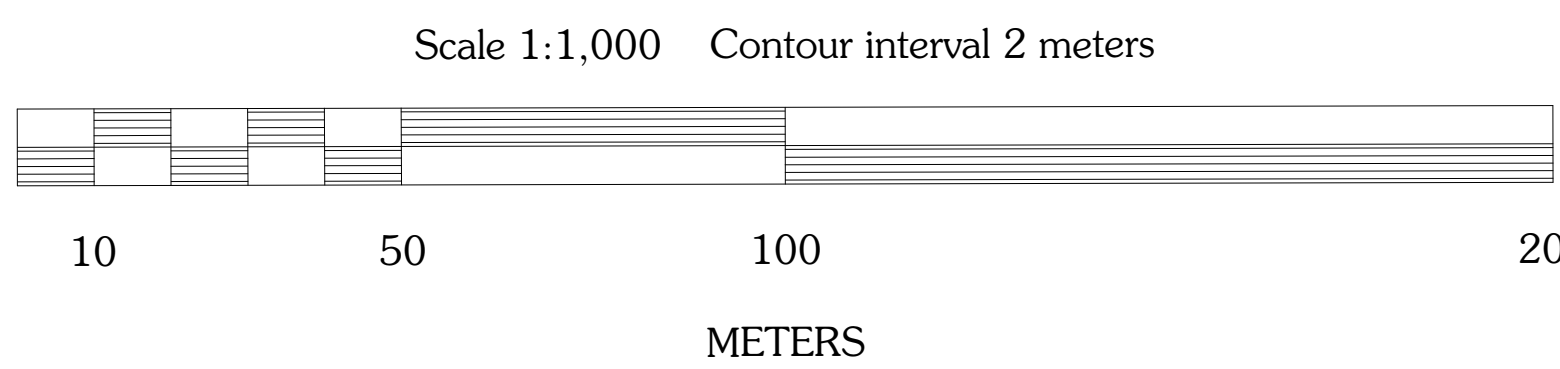
Aerial photos from 7/31/00. Map compiled through photogrammetric means by the USGS Laboratory for Geologic Photogrammetry & Digital Mapping, Denver Federal Center, by James A. Messerich. GIS assistance by Pucco VanSteele. Photos nominal scale 1:6,000. Colorado State Plane Coordinate System (southern zone), elevations above mean sea level North American Vertical Datum 1988.
